Publication of the MIRCE Academy

2021 Annals of MIRCE Science

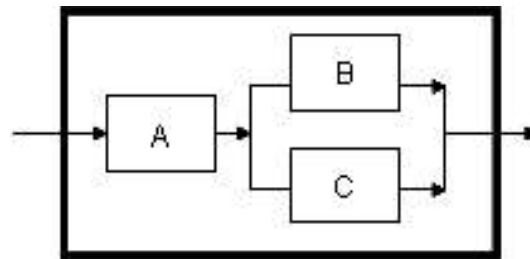
A system is a collection of components on which at least one measure of performance is defined. An expression that defines the state of a system as a function of the states of its components is called a system function, which is a mathematical model of the physical entity considered. Thus, the reliability function for a system, $R_s(t)$, which consists of several components, is determined by the impact of failure of each component on the reliability performance of a system, which is graphically described by the reliability block diagram (RBD) of a system considered. For a hypothetical system that will experience a failure event when either component A fails, or components B and C fail, the RBD is shown in Figure 1.

Figure 1: Reliability Block Diagram for a Hypothetical System

The above two figures summarise the essence of the mathematical approach to the reliability modelling process. As its main concern is a prediction of the probability of a given system not experiencing a failure event during a given interval of time it is the governing information for the safety, hazard and similar types of analyses performed at the design stage.

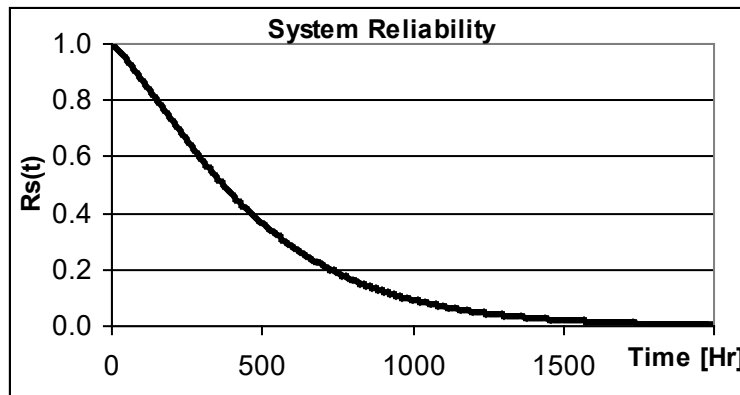
Given that reliability functions of consisting components A, B and C are known it is possible to plot the reliability function for a system and calculate the probability of not experiencing a failure event during any interval of future time, as shown in Figure 2, for a hypothetical system.

Figure 2: Reliability Function for a hypothetical system shown in Figure 1.
